Service Letter No. 445 September, 1995

SUBJECT: Solenoid Flux Ring Failures

MODELS AFFECTED: ALL

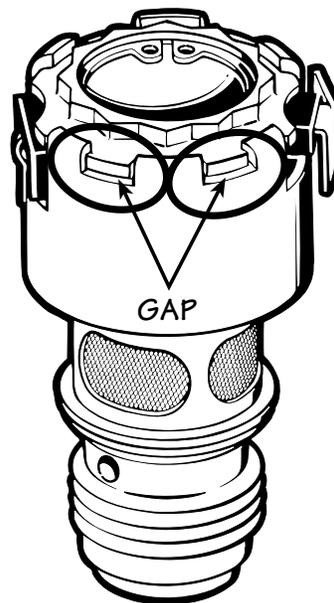
The cause of the failure is a breakdown of the internal flux ring around the solenoid coil which opens up an air gap in the coil's magnetic field. When the air gap gets too large, the magnetic field becomes too weak to hold the solenoid valve open and the engine brake won't turn on. The hotter the solenoid becomes, the weaker the magnetic field. This is due to both temperature and the growth in the air gap (due to expansion). When the solenoid cools down (while troubleshooting in the maintenance shop), it may begin to work again.

The problem can be detected by looking at the gap between the tangs of the solenoid cap and the solenoid cup (as shown below). If this gap is visible (more than 0.010") or if the gap can be closed by pushing on the cap, the solenoid has most likely failed and should be replaced.

If the date code next to the part number on the solenoid is "E5" or greater, the solenoid was manufactured after May, 1995 and has an improved flux ring.
