Low Engine Speed Retarder Cutoff

Troubleshooting Instructions Low Engine Speed Retarder Cut-off

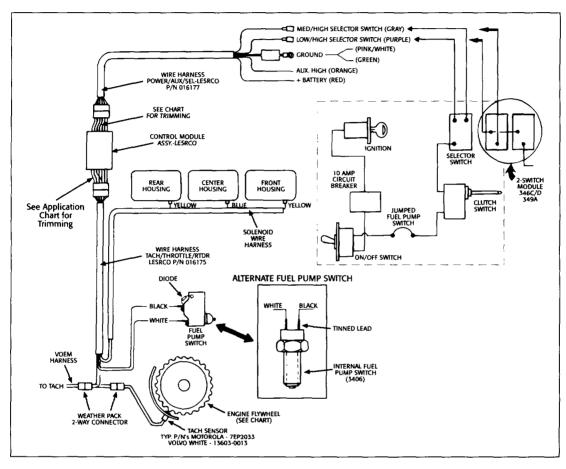
Application Chart

_			
Engine Make & Model	Flywheel Teeth	Cutoff Speed (RPM)	Trim Required
Mack, Cummins NT	118	850	Cut both GREEN/YELLOW and BLUE/WHITE
Cummins 10 Liter	105	950	Cut both GREEN/YELLOW and BLUE/WHITE
CAT 3406	113	880	Cut both GREEN/YELLOW and BLUE/WHITE
CAT 3406	113	1060	Cut GREEN/YELLOW only
CAT 3306	132	910	Cut GREEN/YELLOW only
CAT 3306	156	960	Cut BLUE/WHITE only

Referring to the chart above, select the engine make and model and the desired cutoff speed (RPM) and cut the Control Module wires accordingly. Install caps on the ends of wires for insulation.

Correction: Check application chart (Fig. 1) for proper wires to be cut.

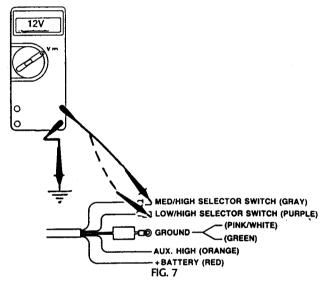
Correction: With the selector switch in LO position, ignition ON and ON/OFF switch ON, measure voltage output at purple wire (Fig. 7). Proper reading should be 12.5 +/- 1 VDC. Measure output at gray wire. Output should be 0 VDC. Select HI position on selector. VOM should read 12.5 +/- 1 VDC at each output terminal.
